*By AE2 Morgan Furlow*

# I Was a Half-Inch From

# m Death

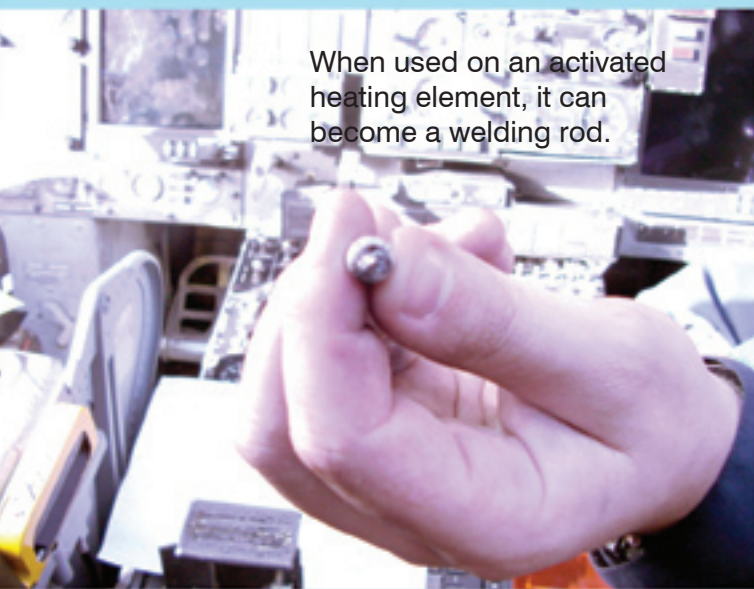
When used on an activated heating element, it can become a welding rod.

phase, 400 HZ, and 35 amps arced from the heating element. I had thought this system was deenergized, but the charred screwdriver in my hand told me different.

I was surprised to say the least. Aircraft power had shut down because of a system overload, and I noticed the scent of burnt metal in the air, reminding me of my high-school welding class. I examined the tool and found that about one-third inch of the screwdriver's tip had melted off.

I learned a few valuable lessons from this experience. I was working on an aircraft without a complete and thorough pre-power check. This was and is unacceptable, and I should have known better. I was working on one discrepancy and allowed myself to get sidetracked on another job. In the process, I did not stop to think through the new task. A can-do attitude and a lax work ethic almost killed me. Had I slowed down, thought through the job, and followed procedures, I could have saved myself a lot of time and trouble.

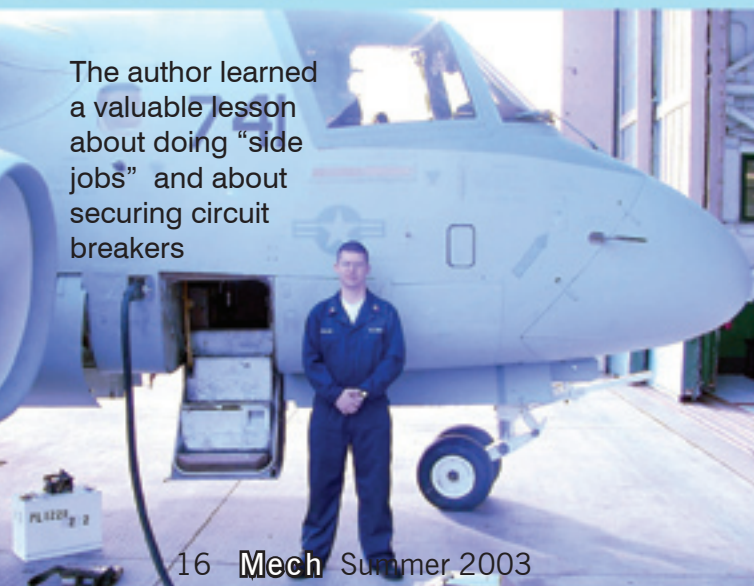
The author learned a valuable lesson about doing "side jobs" and about securing circuit breakers

I took a few seconds to calm my nerves and then checked the aircraft for damage. I found the piece of missing screwdriver had melted onto the head of the screw. With no further damage, I secured aircraft power and went to tell my LPO what had happened.
